CONNECTICUT RIVER BASIN  
SHELBURNE FALLS, MASSACHUSETTS

ALBERT DAVENPORT DAM  
MA 00507

PHASE I INSPECTION REPORT  
NATIONAL DAM INSPECTION PROGRAM

MARCH 1981

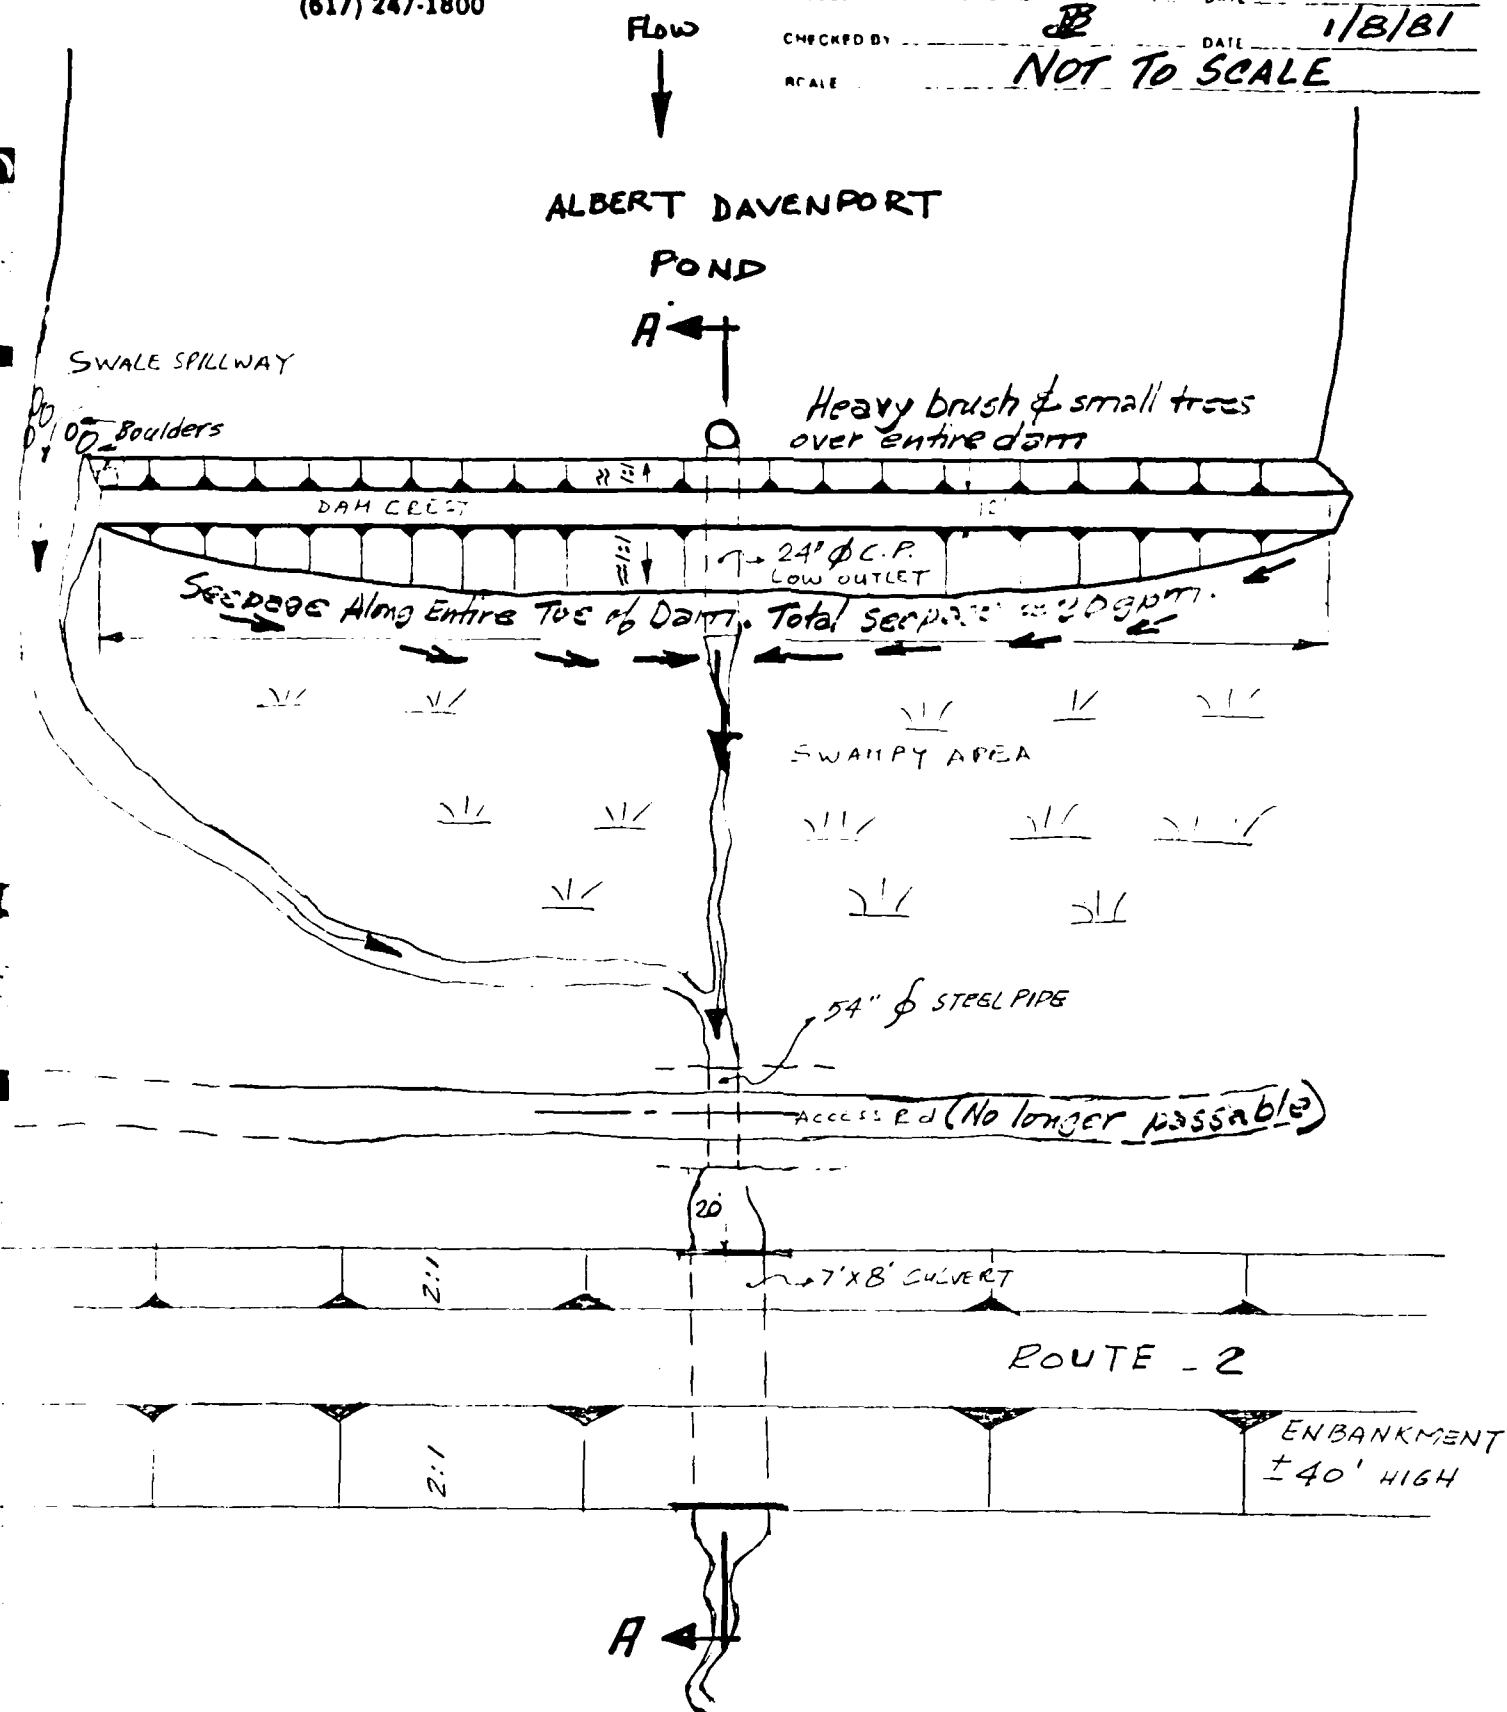
PLAN VIEW DAM SITE &  
SURROUNDING AREA

The dam appears to be in poor condition. Seepage is evident all along the downstream toe. Trees and heavy brush cover the entire dam except for a foot path along the center of the crest.

2. Investigate the source and extent of the seepage observed along the entire downstream toe of the dam.
